Manhole Inspection Summary

Manhole # S25G__013MH

Location Address: **1214 STOCKTON ST**

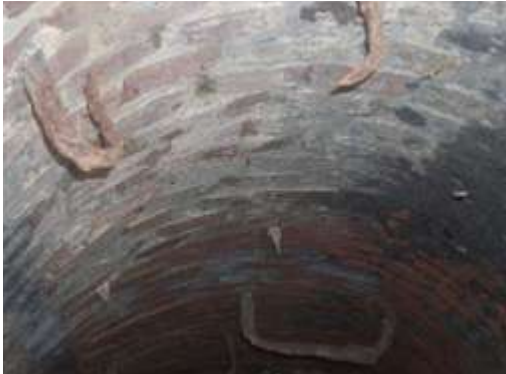
Defect 4

Steps Count: **2** Missing: **3** ☒ **Corroded**

CORRODED AND MISSING STEPS

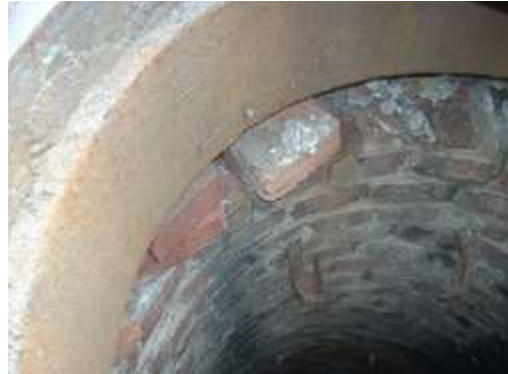
Defect 3

LOOSE CORBEL BRICKS

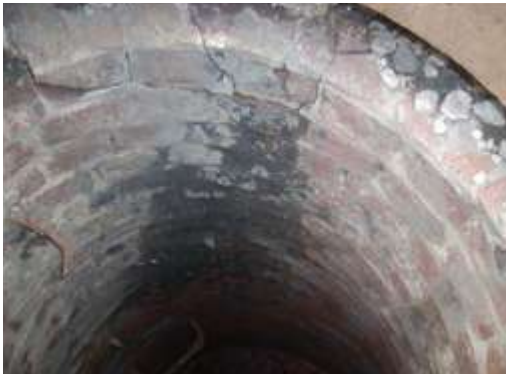
Defect 2

Infiltration: ☐ None ☐ Joint ☒ **Cracks** ☐ Mortar ☐ Roots ☐ Wall

INFILTRATION FROM CORBEL
CRACKS

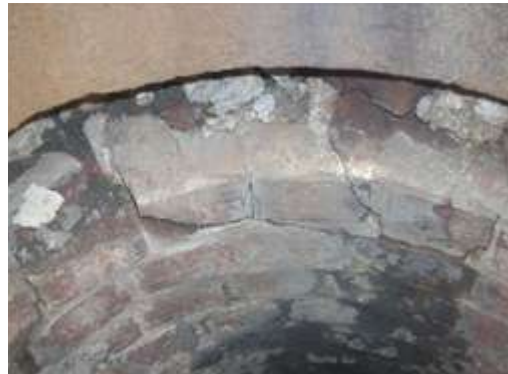
Defect 1

Condition: ☐ Sound ☒ **Cracked** ☐ Root Intrusion ☒ **Loose Brick** ☒ **Deteriorated**

CRACKED AND DETERIORATED
CORBEL

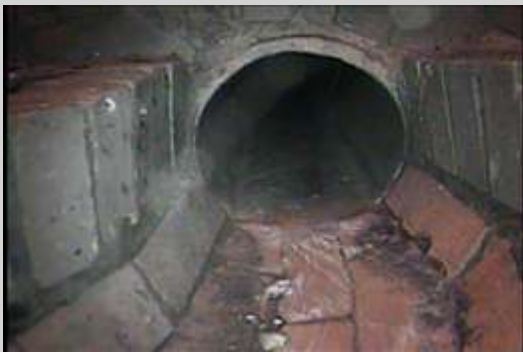
12 O'Clock Outflow

8 in. Circular Gravity Sewer
Pipe Out @ 12 O'Clock

Pipe Height: **8.4** (in.) Rod and Bar (Angled)
Pipe Material: **Clay** ☐ Pipe Lined
Invert Depth: **9.02** (ft.) Flow Characteristics: **Slow**
Deposits: ☒ None ☐ Mud ☐ Sludge ☐ Debris ☐ Grease
Silt Depth: (in.) Deposits Extent:
Infiltration: **None** Pipe Seal Cond: **Sound**

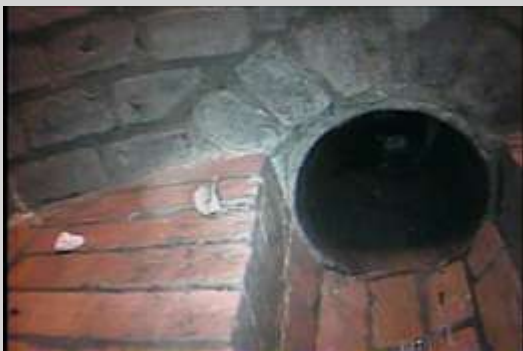
9 O'Clock Inflow

8 in. Circular Gravity Sewer
Pipe In @ 9 O'Clock

Pipe Height: **8.4** (in.) Rod and Bar (Angled)
Pipe Material: **Clay** ☐ Pipe Lined
Invert Depth: **8.47** (ft.) Flow Characteristics: **Slow**
Deposits: ☒ None ☐ Mud ☐ Sludge ☐ Debris ☐ Grease
Silt Depth: (in.) Deposits Extent:
Infiltration: **None** Pipe Seal Cond: **Sound**
